Section B Design Guidance

Section C Case Studies

Section C documents thirteen case studies with a set of standard technical drawings, project description, photographs and Bills of Quantities. In addition the technical drawings are annotated with recommended improvements to the design in blue boxes. The case studies are arranged in an order from the simplest TLS project towards the most complex and long lasting semi-permanent structures.

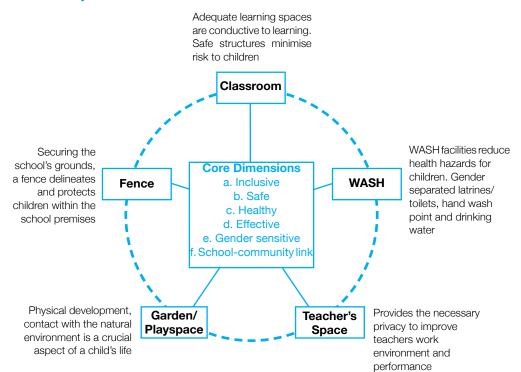
Fig.2 Core Dimensions of Child-Friendly Schools

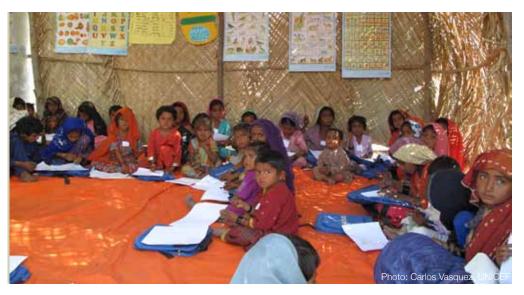
Internal view of bamboo clad structure with tarpaulin floor

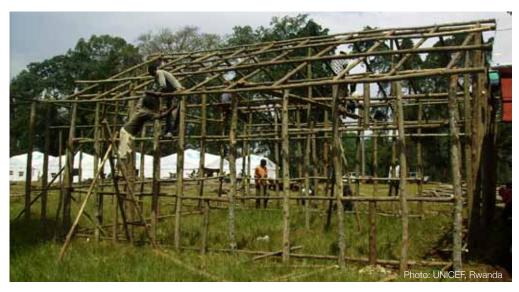
Wooden pole lattice structure, TLS under construction

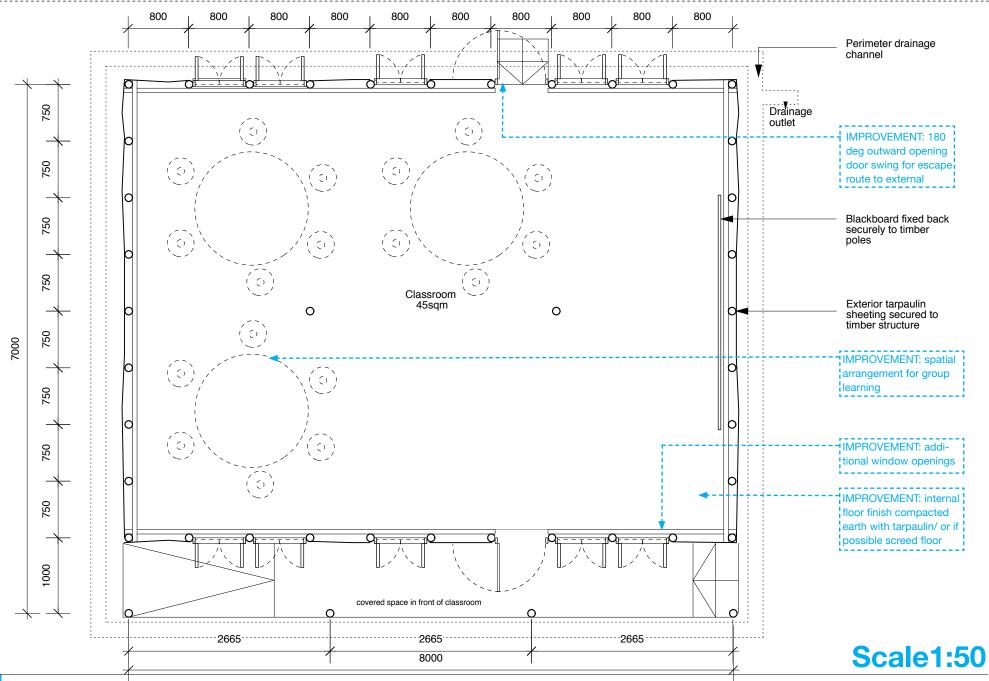
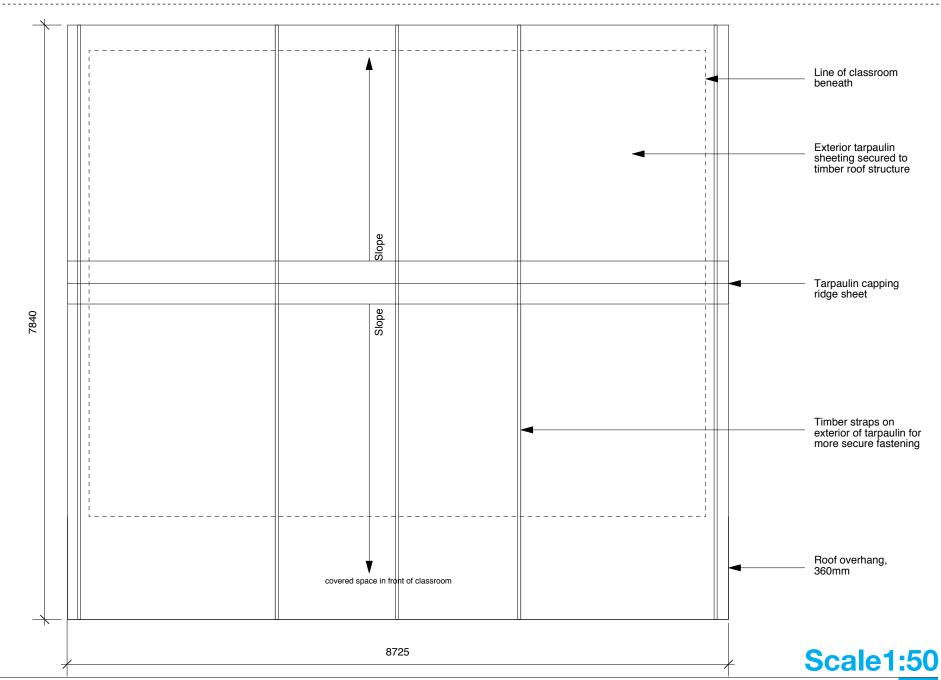
Tarpaulin ridge capping sheet Tarpaulin roof sheeting 20mm timber strapping for tarpaulin 360 IMPROVEMENT: additional window openings 3950 2160 Tarpaulin exterior sheeting 1000 IMPROVEMENT:compacted earth raised floor level to prevent flooding 450 IMPROVEMENT:stone/ce-IMPROVEMENT: access ment retaining edge ramp and steps 2665 2665 2665

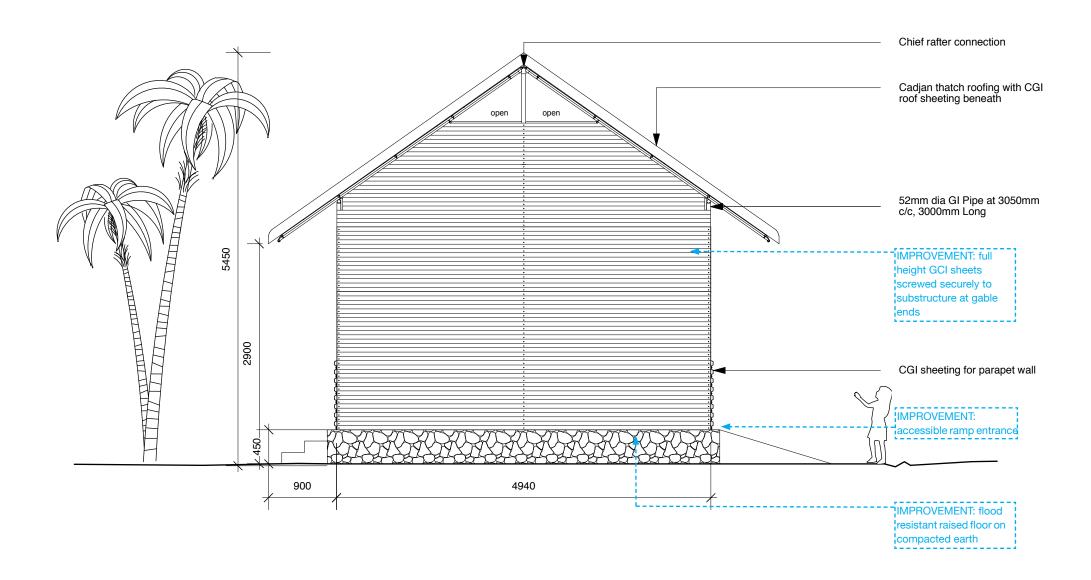
IMPROVEMENT: accessible entrance ramp CGI sheet walls, substructure to wall cladding needed especially around doors. Entrance Entrance Entrance Entrance Entrance Line of roof overhang 2450 IMPROVEMENT: spatial arrangement for group learning Classroom 15 sqm 4900 52 dia GI Pipe 2450 Blackboard fixed back securely to pipe structure IMPROVEMENT: steps up to raised floor level 950 1525 1525 1525 1525 1525 1525 1525 1525 1525 1525

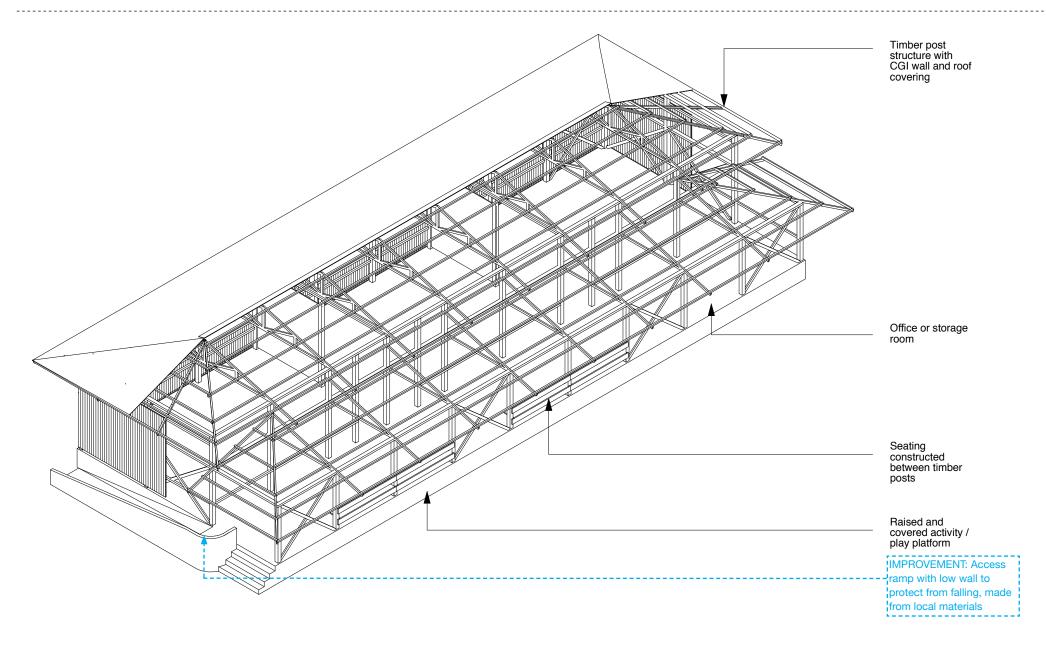
IMPROVEMENT: spatial Line of roof Window Chalkboard Window CGI sheets **IMPROVEMENT: Access** overhang opening 1800 x 1200 opening as exterior arrangement for group ramp with low wall to mm cladding learning protect from falling, made from local materials 24000 2667 2667 2667 2667 2667 2667 2667 2667 2667 1200 9000 Classroom 1 48 sqm Classroom 2 48 sqm Classroom 3 48 sqm Door Door Door 1180 1200 Administration Office 3000 15 sqm 1700 1:10 min ramp 140 x 140 Cross bracing Verandah Timber Window Metal roof Timber balustrade and opening sheets structure seating

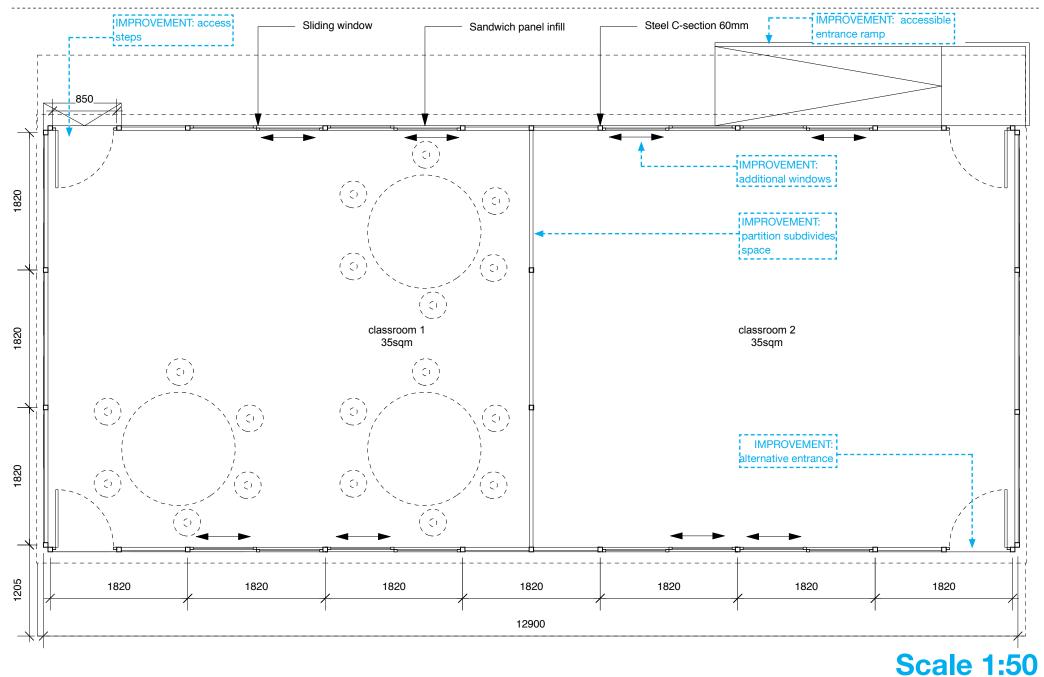
Ground Plan

Metal roof extension for shading and weather protection Metal sheet ridge capping Profiled metal roof 7691 Slope 13140

Wire bracing bolted tied to steel uprights Sliding windows Sandwich panel inf II Prof led metal roof 1420 open open open open Door Door steps 3000 1120 12900 Steel channal sole plate bolted to concrete foundation Concrete plinth foundation raised 350mm IMPROVEMENT: accessible IMPROVEMENT: entrance ramp Lower windows allow views outside

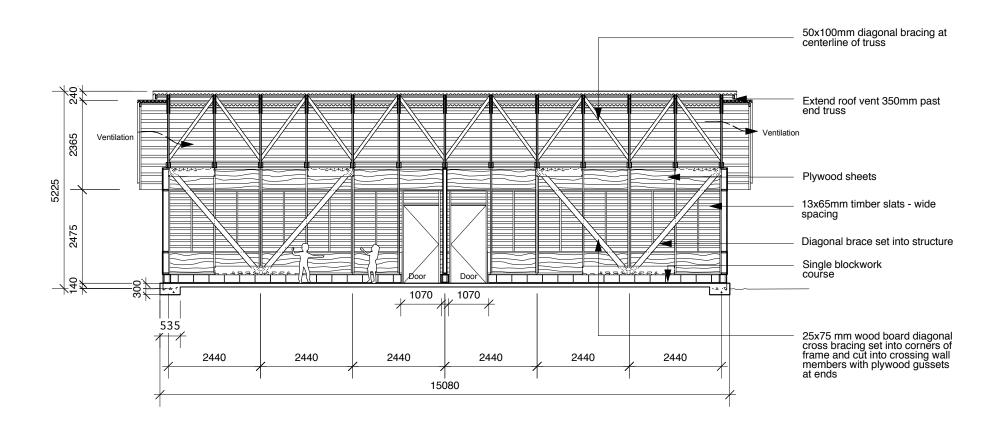
Extend roof vent by 300mm 13x65mm timber slats - dense spacing 12mm timber end sheet panal Aluminum gutter both sides of roof white color 3050mm length 15,250mm total length downspout at one end. Hidden gutter hangers @ 600mm on centers 1415 Recycled oil drum cleaned and painted for rain water harvesting IMPROVEMENT: accessible lentrance ramp Single blockwork course 7320 Plywood cladding Steel straps attach timber studs to concrete base

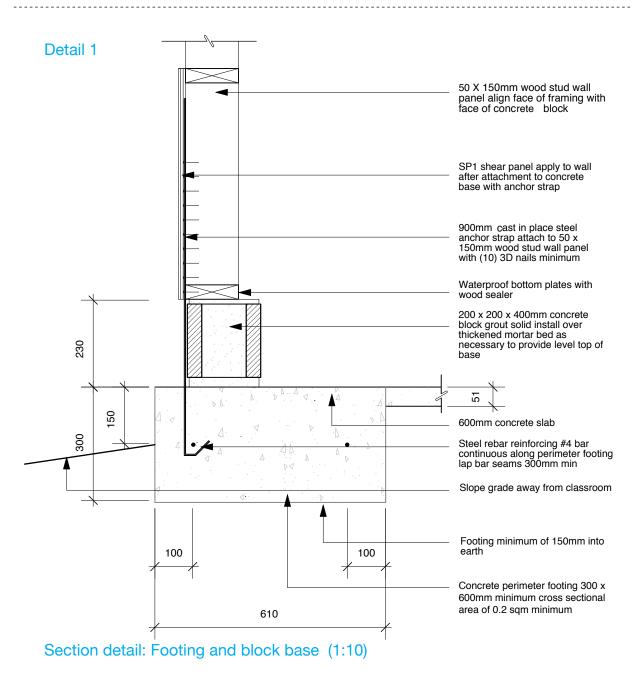
Ventilation Ventilation Steel strap between end truss and wall panel below Steep straps between truss and timber stud 2365 Detail 2 Ondura corrugated asphalt roofing - Gutter channel 1415 Timber panel post 140x40mm Ventilation Ventilation 3191 13x65mm timber slats - dense spacing Alternate blackboard position Blackboard Detail Plywood cladding at base Concrete foundation and 100mm concrete slab. Single blockwork course 535 2440 2440 2440 13x78mm wood board diagonal set into corners of frame cut into crossing wall members plywood gussets at ends 7320

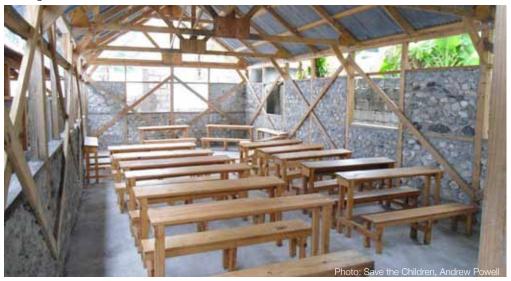
Internal view of upgraded timber version

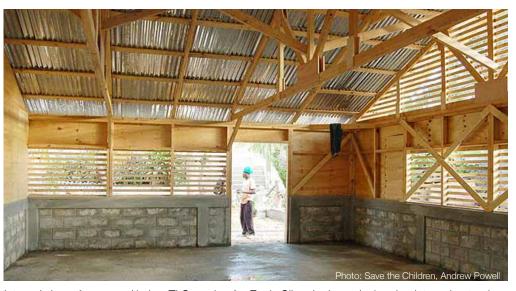
Internal view of masonry/timber TLS version for Ecole Siloe in Jacmel, showing internal natural lighting condition

In the case study of Haiti C12.0 P170, timber wooden louvers on the outside diffused the sunlight to give even filtered lighting condition.

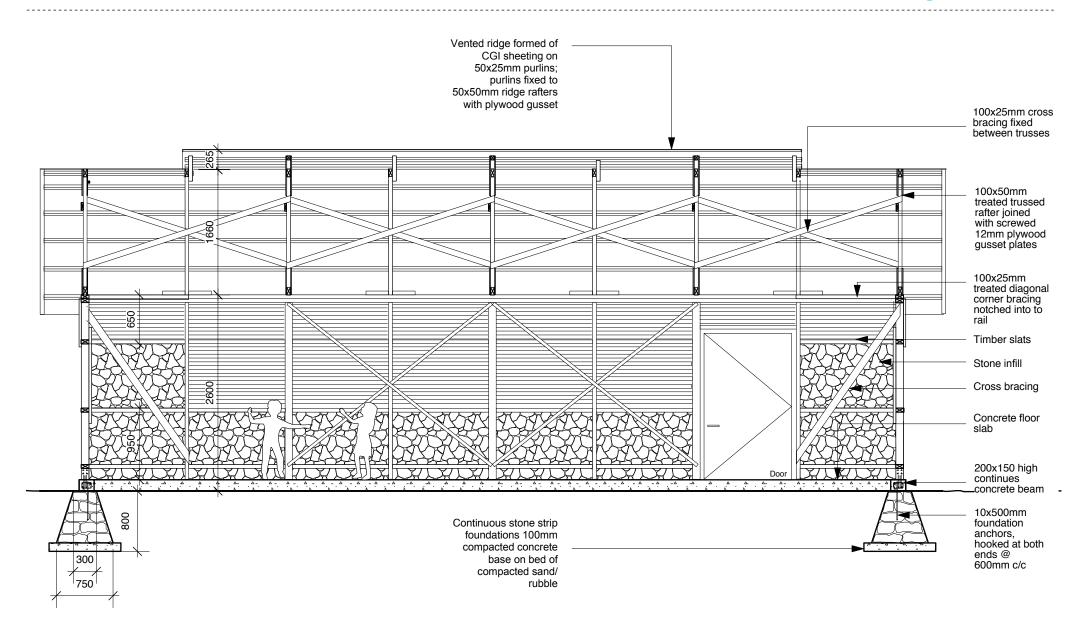
Option1: Long Section

Vented ridge formed of CGI 50x50mm impregnated sheeting on 50x25mm purlins fixed to rafters with purlins, purlins fixed back to hurricane ties 50x50mm ridge rafers with plywood gusset CGI sheeting fixed to purlins below with galvanised or s.s ringshank nails or woodgrip Ventilation Trussed rafters formed from screws through top of rib and 100x50mm treated timber separated from sheet with fixed by plywood gusset rubber gaskets plates Hurricane strapping to secure CGI roof sheeting 100x100mm treated wall 150x25mm treated gutter board screwed to end of 650 trussed rafters Corner cross bracing with screwed 12mm plywood 100x50mm treated mid rail gusset plates skew/nailed between vertical studs Ventilation 2600 Ventilation 100x50mm treated intermediate vertical studs/ 100x100mm studs bolted Cross-bracing back to galvanised metal plates cast into concrete ring beam 150 300 200x150 mm high continuous concrete ring Continuous stone strip. beam foundation, stones to be laid horizontally 2550 2550

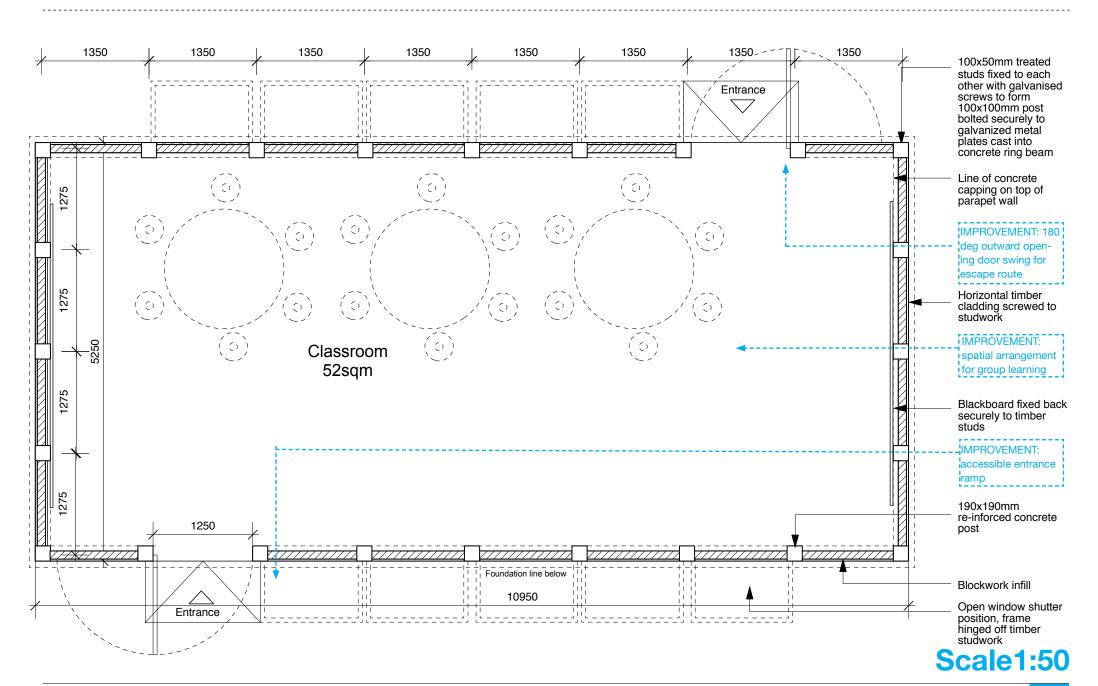
Vented raised ridge detail Hurricane strapping to CGI roof sheeting 4550 Plywood cladding open 1100 Blockwork infill 1250 190x190mm re-inforced concrete post 1350 1350 1350 1350 1350 1350 1350 1350 IMPROVEMENT: 10800 accessible entrance ramp

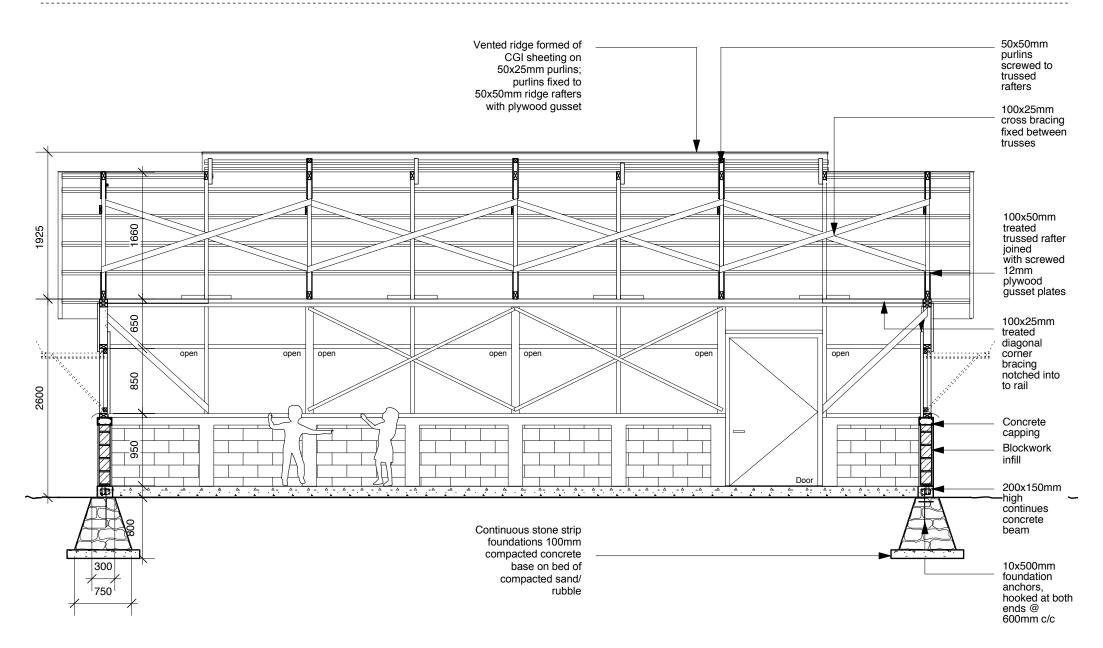
Option 2: Long Section

Vented ridge formed of CGI sheeting on 50x25mm purlins, 50mm x 50mm impregnated purlins fixed to rafters with hurricane ties purlins fixed back to 50x50mm ridge rafers with plywood gusset CGI sheeting fixed to purlins below with galvanised or s.s ringshank nails or woodgrip Ventilation screws through top of rib and separated from sheet with rubber gaskets Trussed rafters formed from 100x50mm treated timber fixed by plywood gusset plates Hurricane strapping to secure CGI 100mm x 100mm treated wall roof sheeting plate 150x25mm treated gutter board screwed to end of 650 trussed rafters 525 Corner cross bracing with nailed 12mm plywood gusset 100x50mm treated mid rail plates skew/nailed between vertical studs Ventilation Ventilation 100x50mm treated mid rail 2600 skew/nailed between vertical studs 100x50mm treated intermediate vertical studs/ Concrete capping 100x100mm studs bolted back 190x100mm high to galvanised metal plates cast 950 into concrete ring beam Blockwork infill 200x150mm high continuous ett. _concrete ring beam 300 IMPROVEMENT: accessible 800 entrance ramp 750 2548 2550 Continuous stone strip foundation, stones to be laid horizontally

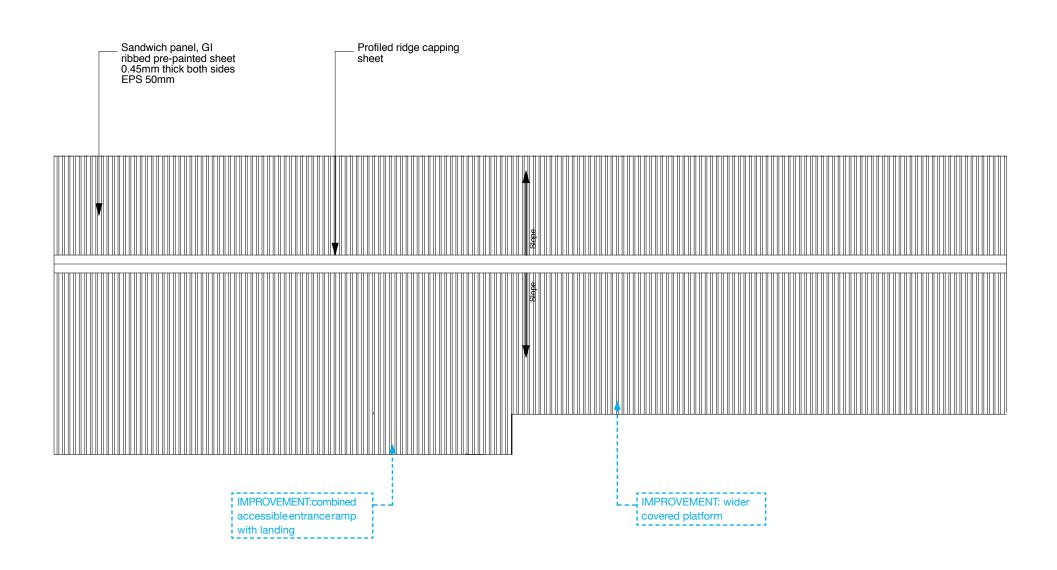
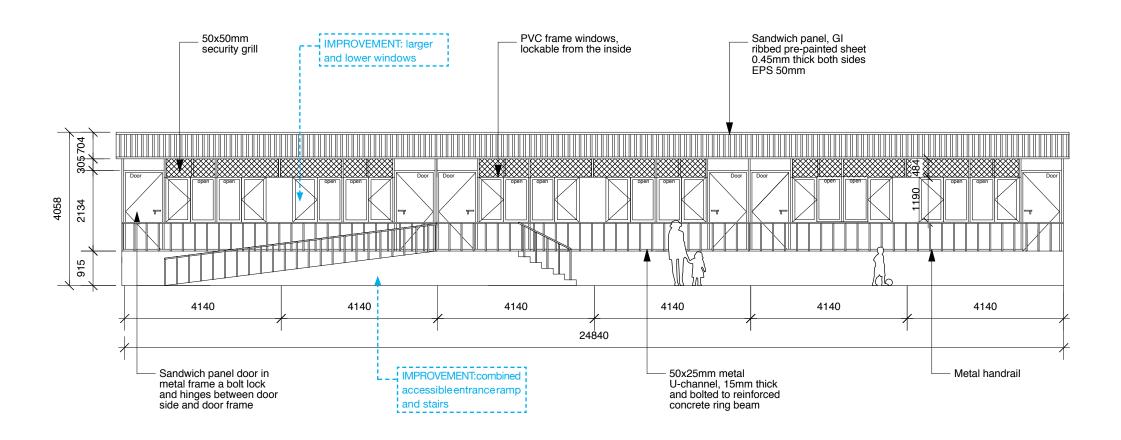
IMPROVEMENT:spatial 180 deg windows with hooks to wall eye Hollow steel tube, Internal concrete floor Line of roof overhang arrangement for group 75x50mm learning 24840 4140 4140 4140 4140 4140 4140 2388 classroom 2 classroom 3 40sqm 40sqm classroom 1 2388 40sqm Entrance 1500 1018 IMPROVEMENT: larger IMPROVEMENT:combined -IMPROVEMENT: wider Sandwich panel with 50mm EPS insulation and GI pre-painted sheet slightly profiled on both sides 0.45mm thick windows accessible entrance ramp covered platform and stairs

Sandwich panel, GI ribbed pre-painted sheet 0.45mm thick both sides EPS 50mm Plinth protection, 75mm thick (1:3:6) Metal truss Sandwich classroom 50x50mm IMPROVEMENT: larger partition 50mm security grill and lower windows 3158 900 4140 4140 4140 4140 4140 4140 24840 Sandwich panel with 50mm EPS insulation and GI pre-painted sheet 100mm PCC (1:2:4), panelled at 1200x1200mm 75mm rammed stone ballast base to blockwork Compacted earth 75mm brick or stone ballast with 75mm sand foundation with reinforced
