# THE POWER SYSTEM IN THE EYE OF THE STORM

## The Call for Energy Resilience and Climate Adaptation in Belize

Migara S. Jayawardena  
Borja Garcia Serna  
Jace Jeusun Han

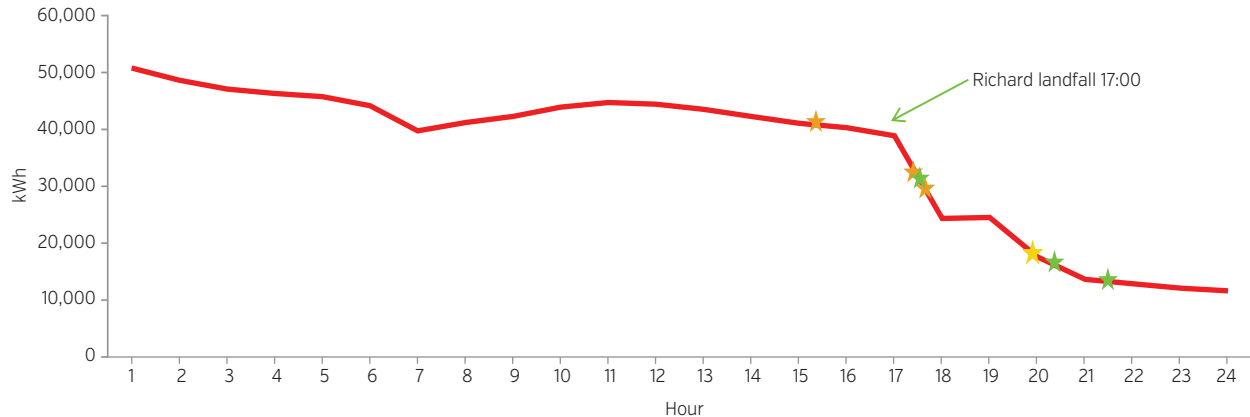
**FIGURE 15.** Impact of Hurricane Richard on Hourly Dispatched Electricity Generation

- ★ Belize District – Distribution line: System restoration, HV lines, affecting:
  - 14:30 – 623 customers for 3 days
  - 16:47 – 7,252 customers for 1–2 days
  - 16:52 – 5,003 customers for 2 days
  - 17:03 – 8,061 customers for 1 day
  - 17:13 – 540 customers for 3 days

- Distribution lines
  - 19:23 – Feeder failures affecting 6,726 customers for 1–2 days
